**GEOTECHNICAL DISTRESS STUDY**

**CAPITAL ONE BANK**

**KELLER BRANCH**

Project No. 10-113

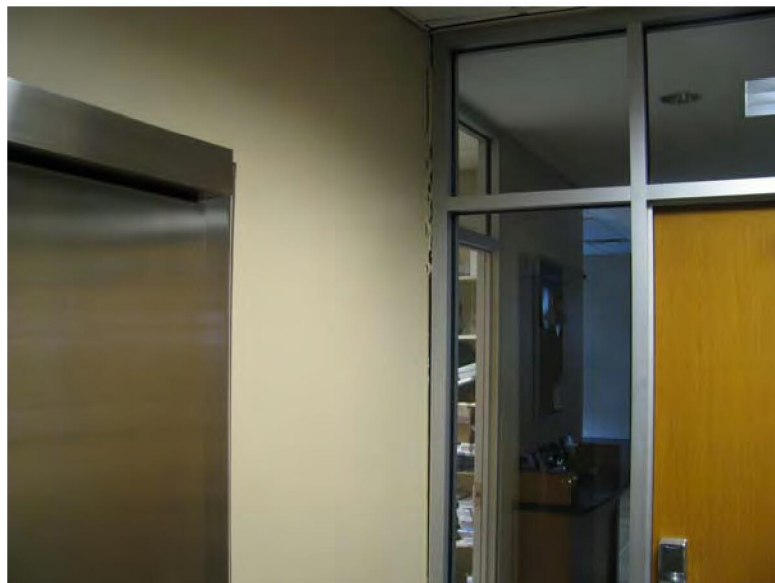
Differential movement caused cracks in interior sheetrock walls and tile floors, unlevel floors, sticking doors, movement of ceiling tiles, and cracks in exterior walls. The doors have been adjusted, and cracks in the dry wall have been fixed as they occurred. Photos were taken in March 2008, and August 2009 documenting the on going problems.

Separation between door frame and dry wall

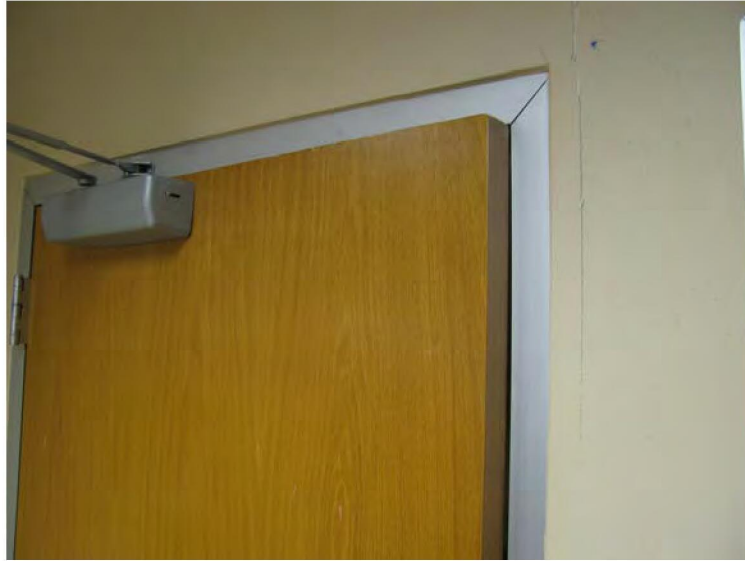
Sticking bathroom door

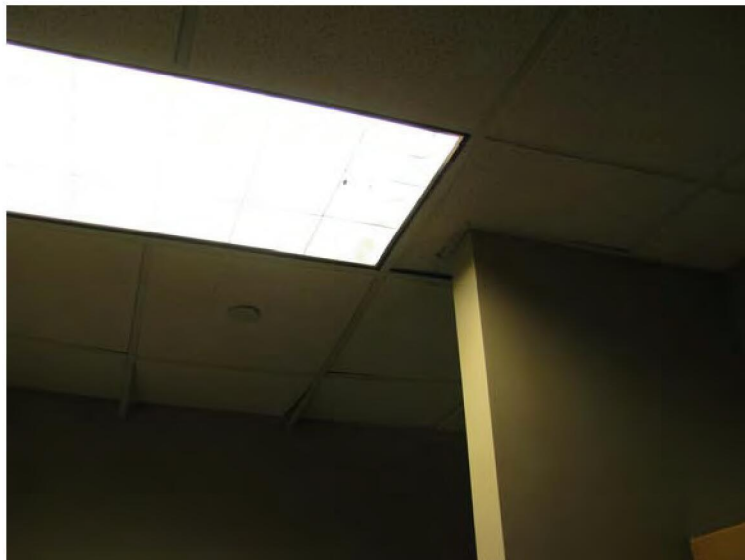
Movement of Ceiling Tiles
