# THE C.T. BRANNON CORPORATION

December 3, 2021

Re: Keller Pointe Pool Deck Report

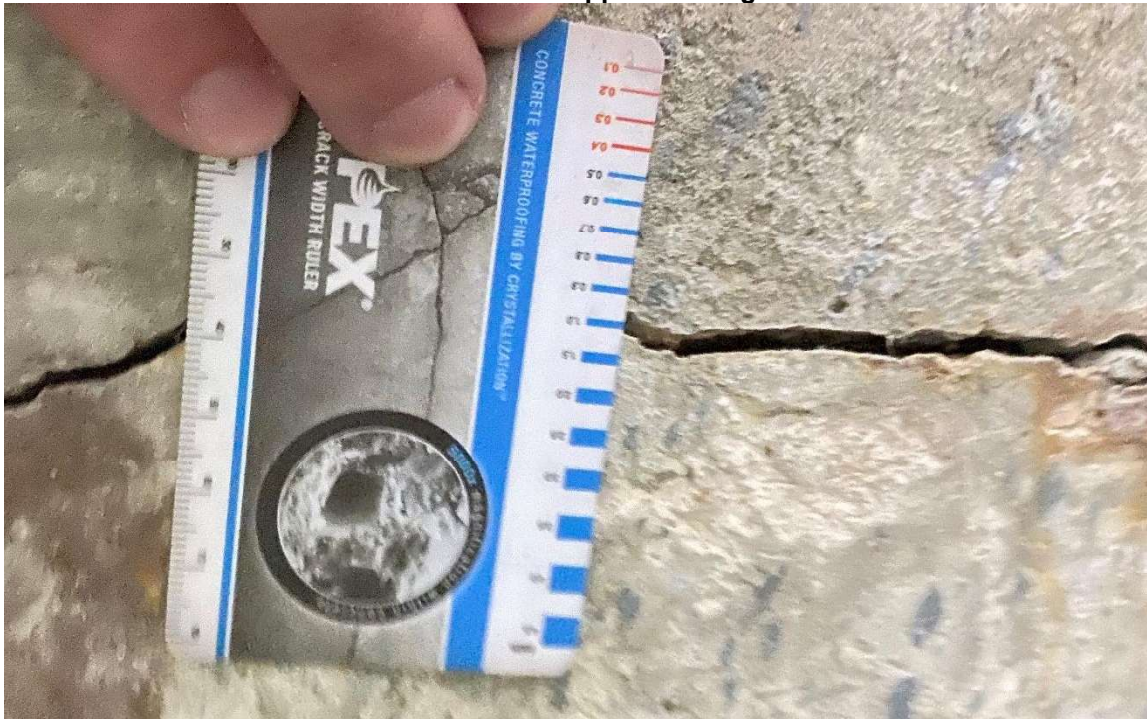
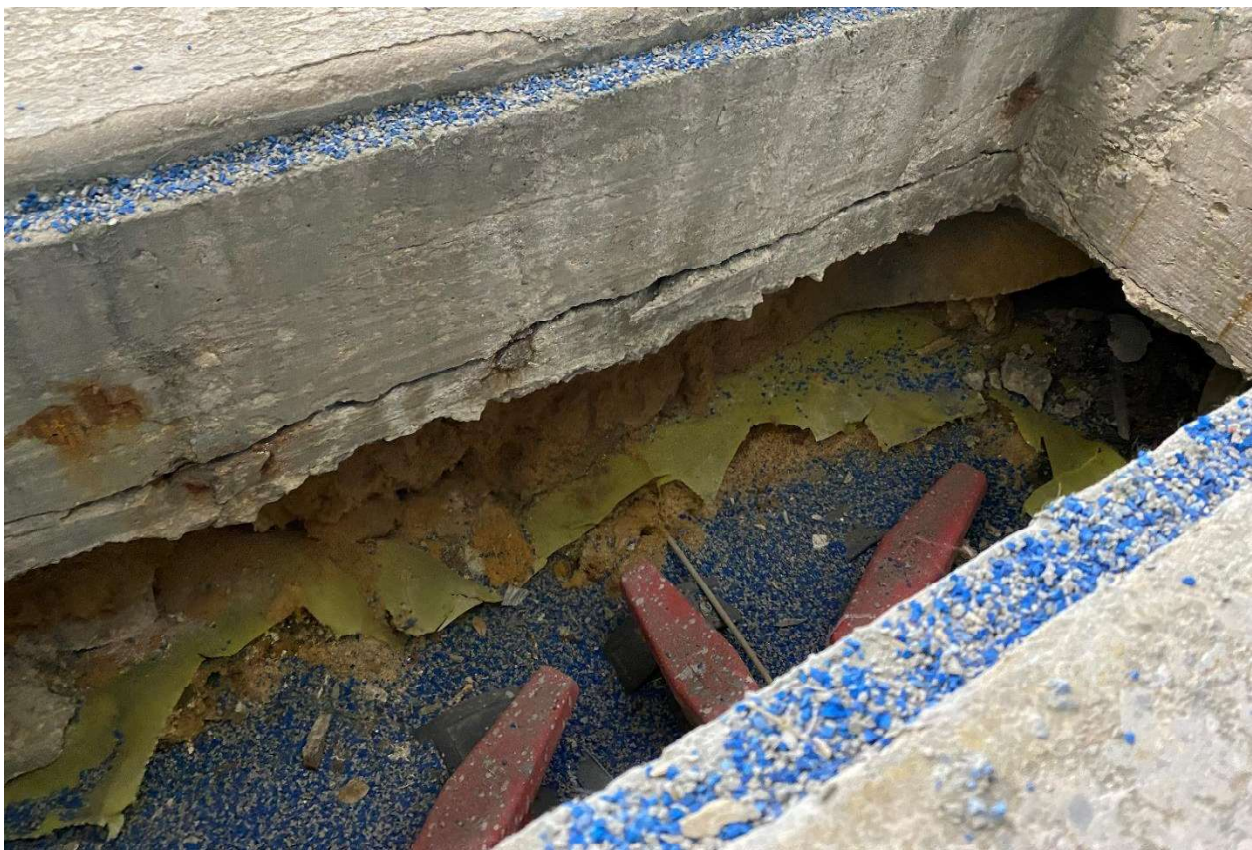
My primary concern, horizontal cracking, was observed in the field and measured, Figures 1 & 2. The deck has five leave outs with grating over the top to allow access to valves installed below the deck. Each of these locations have a horizontal crack midspan of the deck. I measured the largest approximately 3mm (1/10"). I was able to remove sections of rebar and concrete with my hand Figure 15. Corroded steel pieces are below the crack gauge for scale in the image. The cross sectional area of reinforcing has been corroded past allowable conditions.

Corrosion of the reinforcing steel may be the cause or result of the horizontal cracking visible from the leave outs for valves. The original designers provided reinforcing steel to resist tension loading in the suspended deck. If this steel is reduced in strength, the deck may not be able to resist anticipated loading.

However, if corrosion and horizontal cracking in the slab are limited to the valve leave out locations, then removal and replacement could be limited to panels rather than the entire deck.

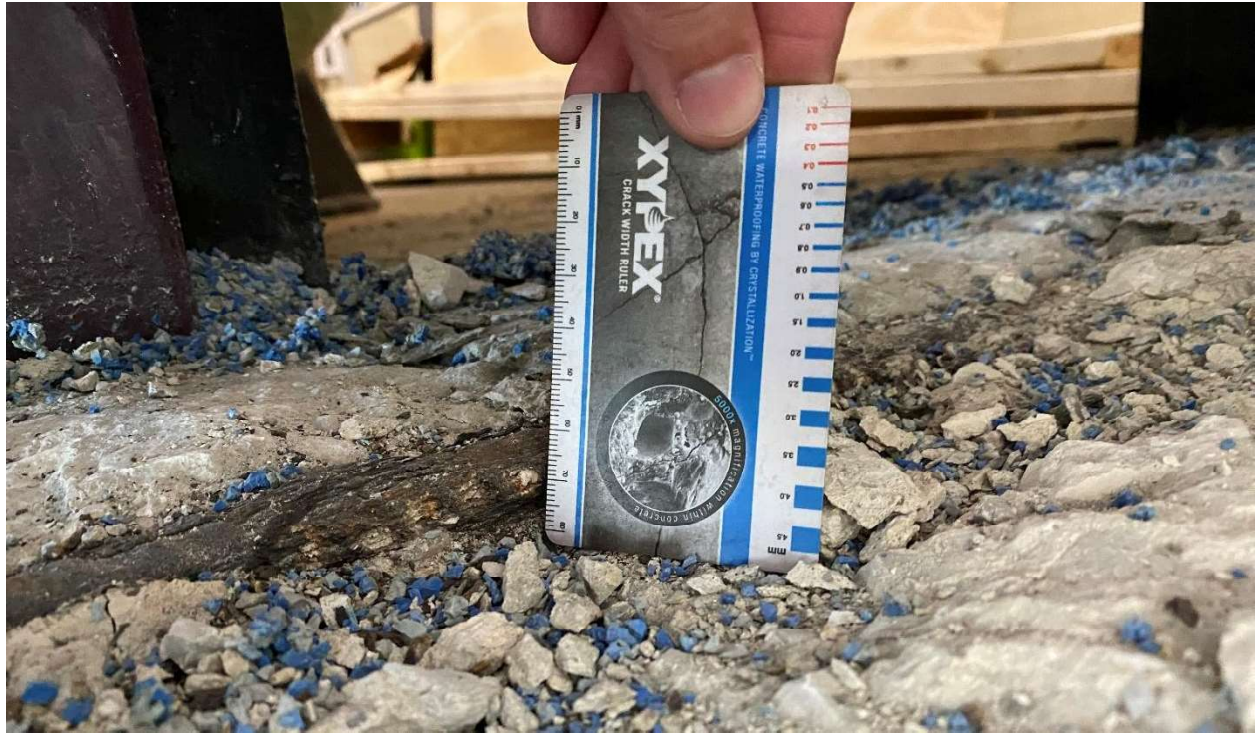
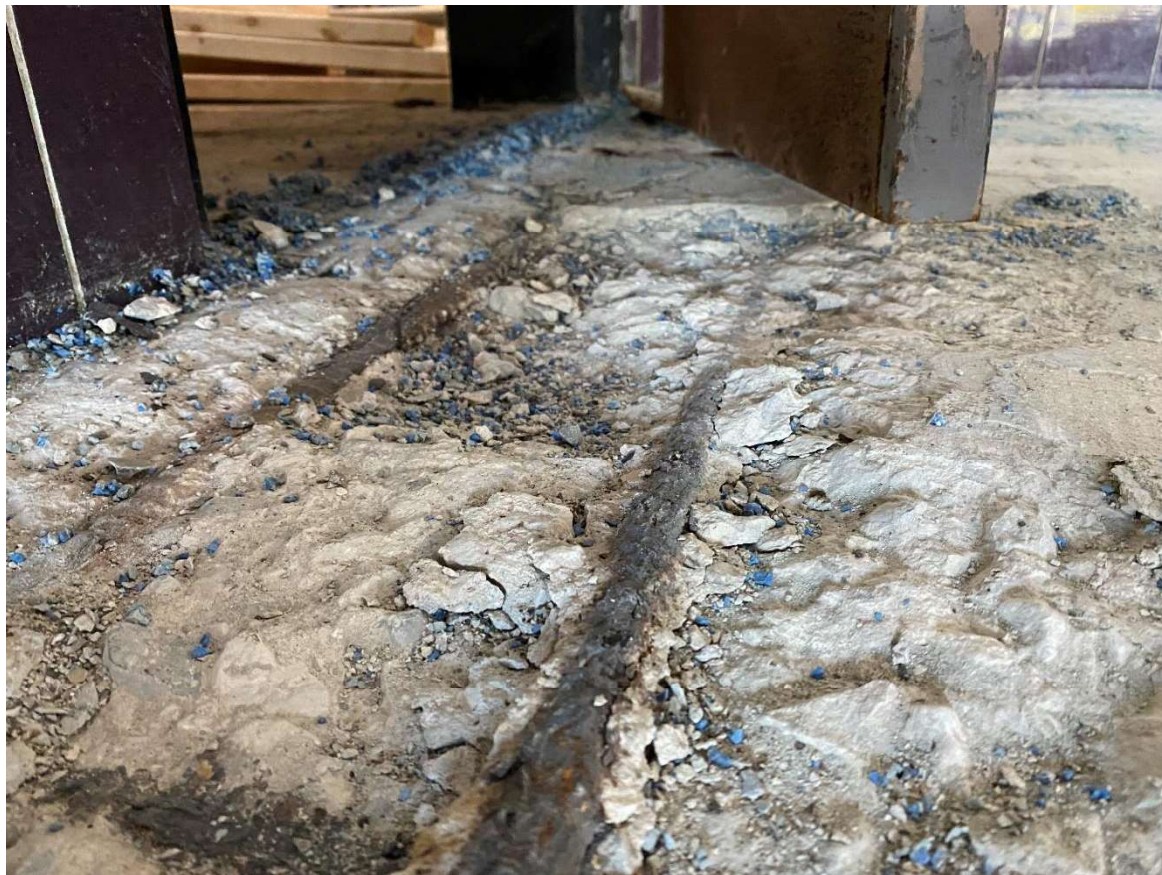
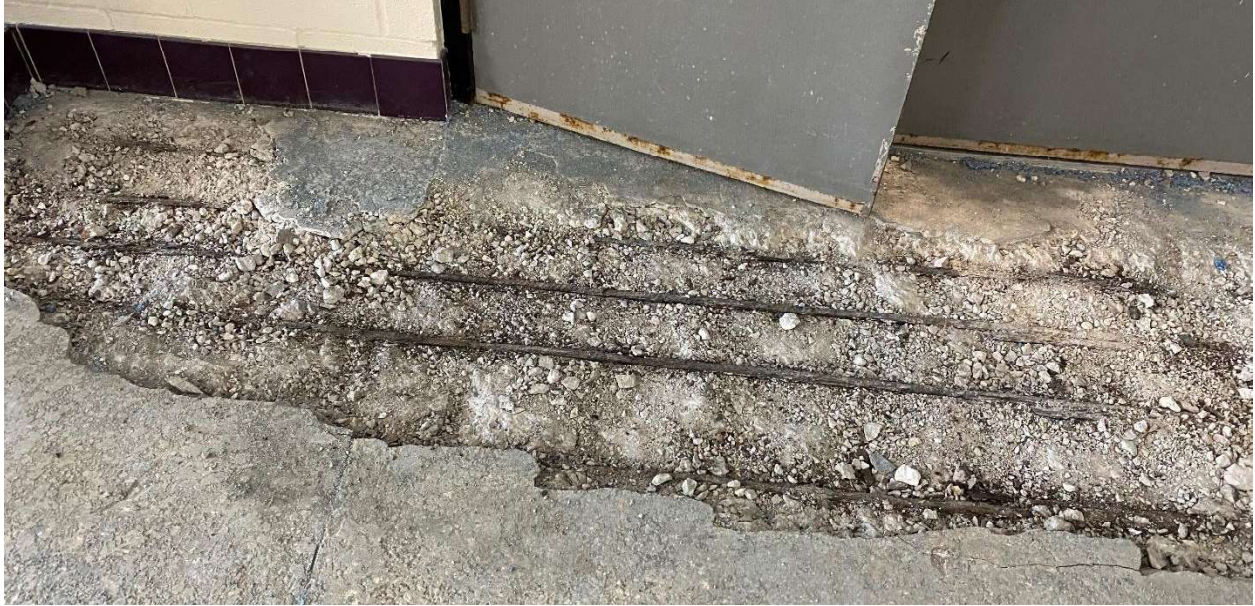
ACI 316 -Concrete for Building structures indicate 1.5" concrete coverage recommended for the installed condition. Rebar adjacent to the double doors does not appear to have adequate cover of concrete Figure 3, 4, 5, & 6.

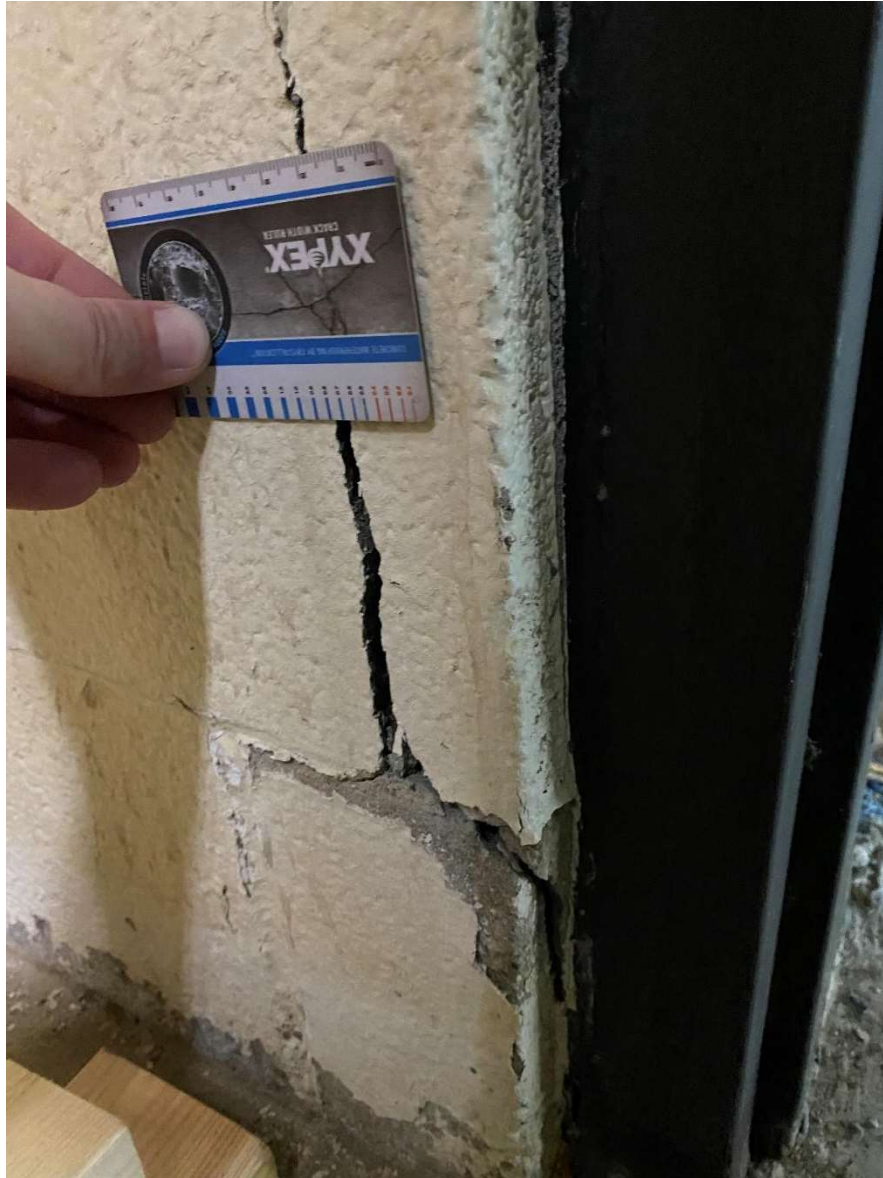
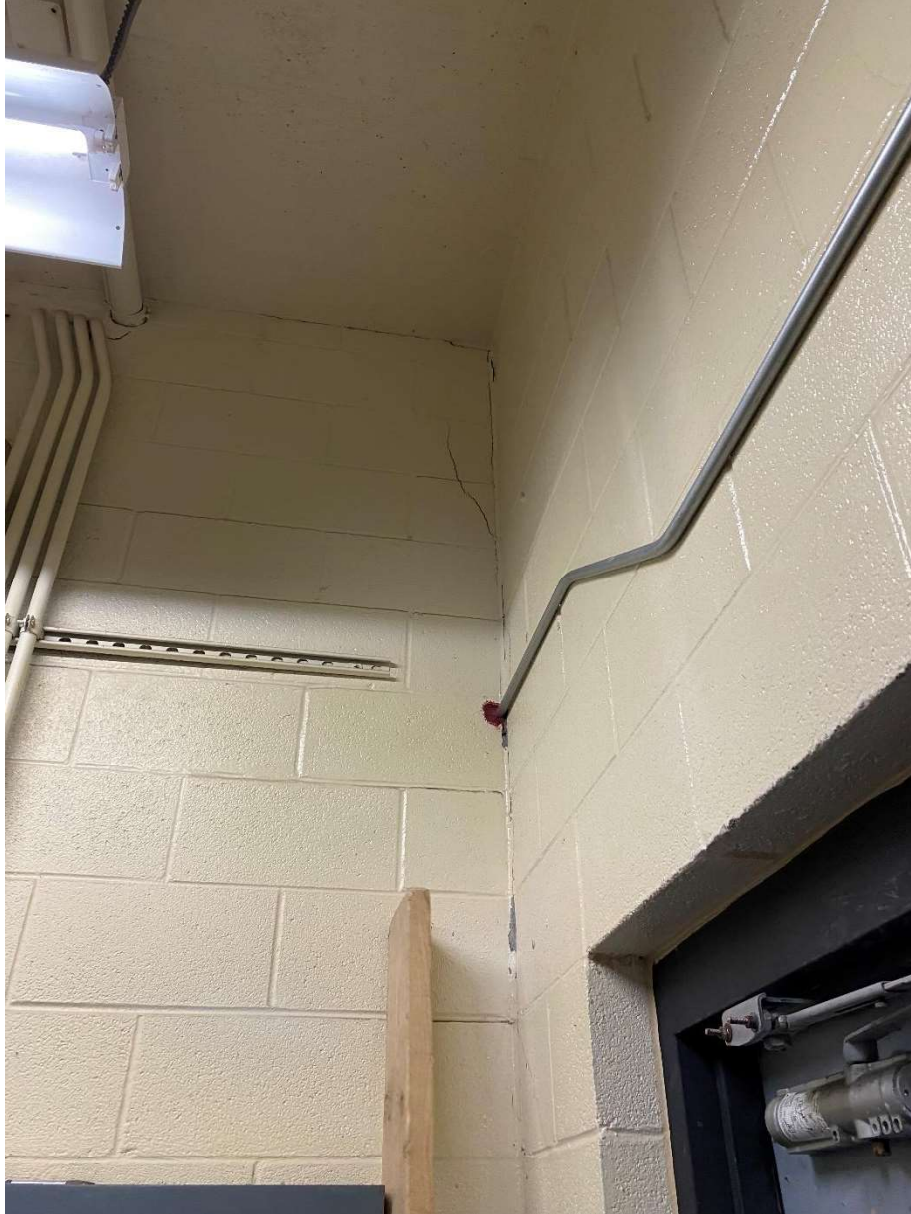
Further evaluation of the facility located cracking in the North CMU wall, Figures 5 & 8. Furthermore, the cove tile at the base of the wall indicates movement.

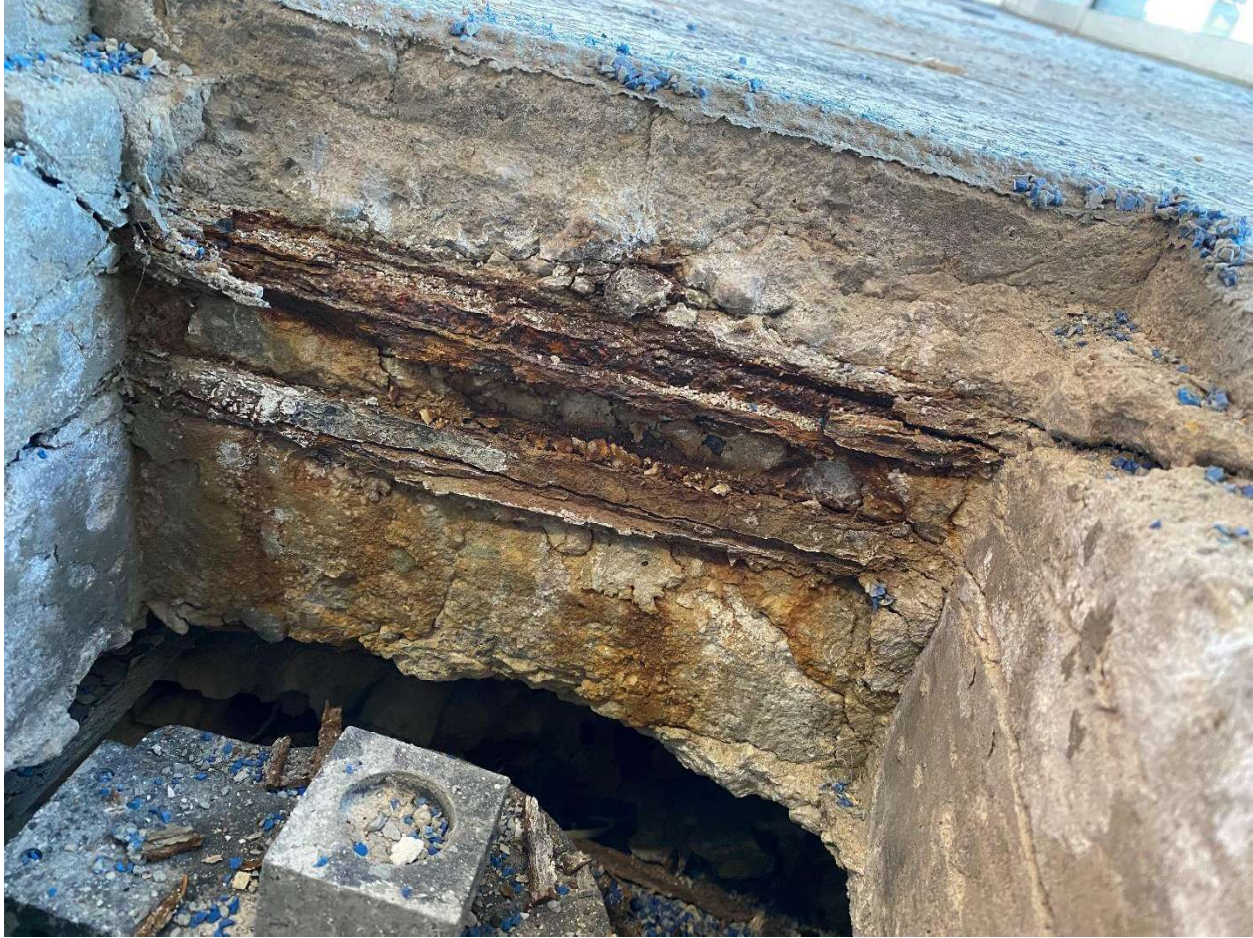
Figure 10

Two of the leave outs for valves indicate rebar was installed to close to the formwork. In some cases, no concrete cover appears to have ever been provided Figure 10.

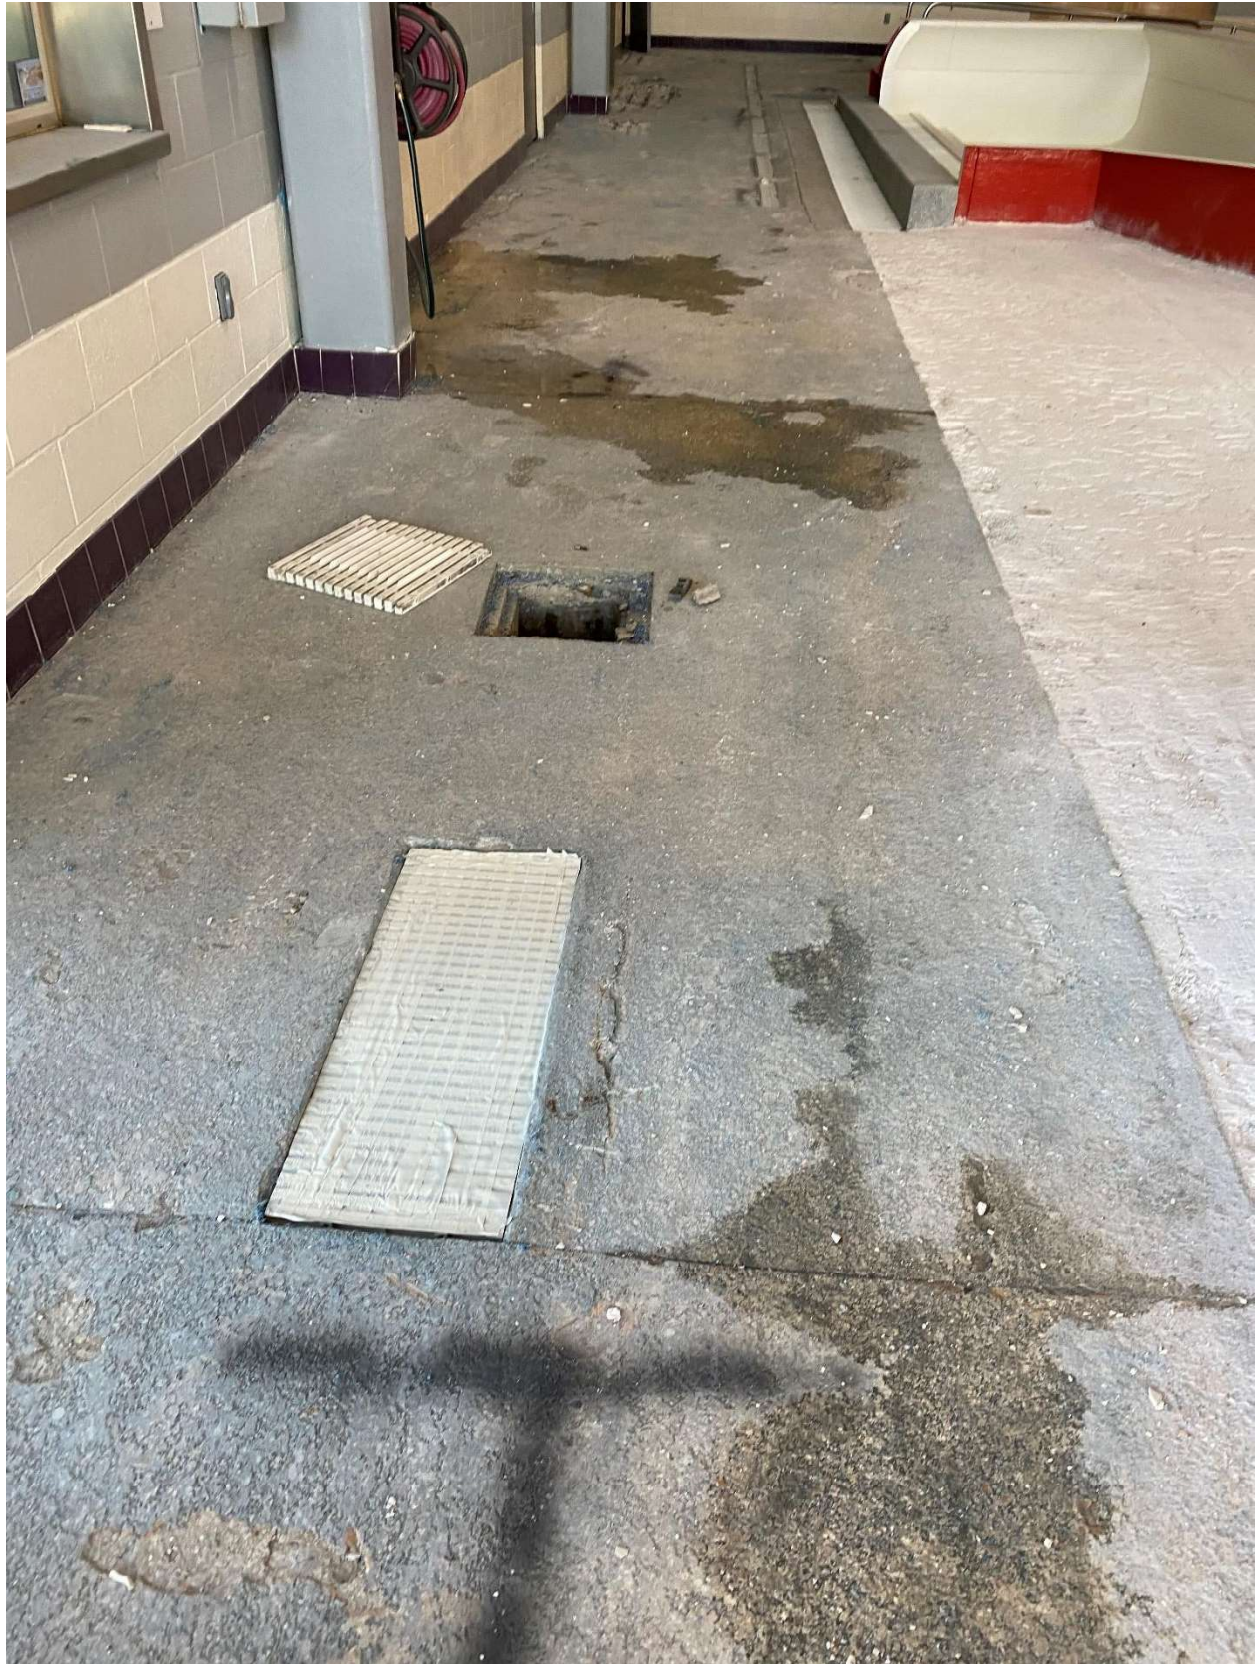
Figure 11

I observed a failed butterfly valve flange below the pool deck as well at the north western leave out. The smaller of the two leave outs west of the double doors, Figure 11.

Valves should also be evaluated for condition while they are exposed.

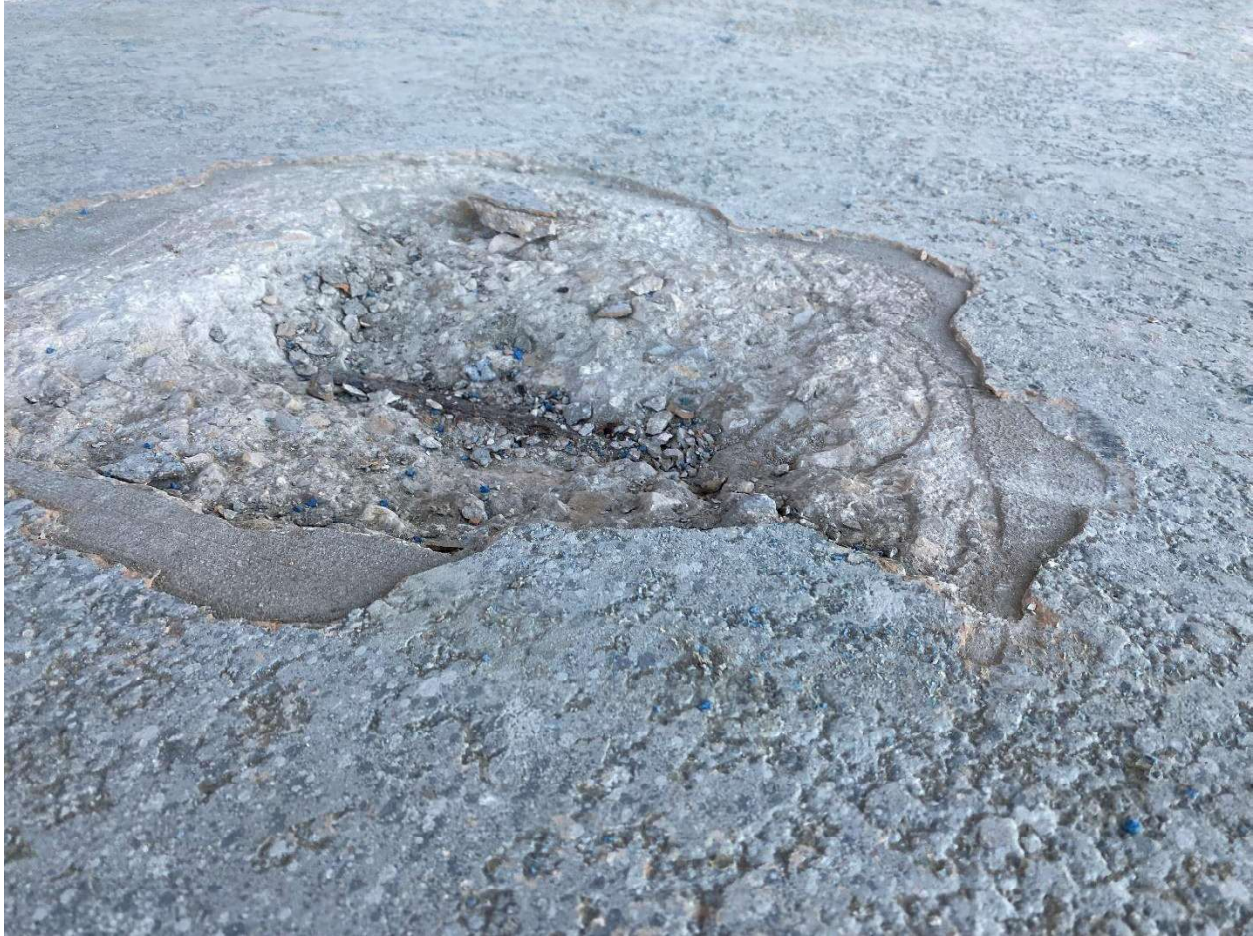
Figure 12

I observed several locations of 'pop-offs' Figure 12, locations where concrete has spalled away from the reinforcing. Some locations have been enlarged by demolition efforts during the removal of the granular rubber finish.

Smaller spalls and pop-offs (<2 sq. ft.) can be hydro-demolished with high pressure water to reveal corroded rebar to determine the extent of corrosion. If corrosion is limited, splicing in new reinforcing and grouting with a hydraulic cement can resolve several of the smaller spalled locations.

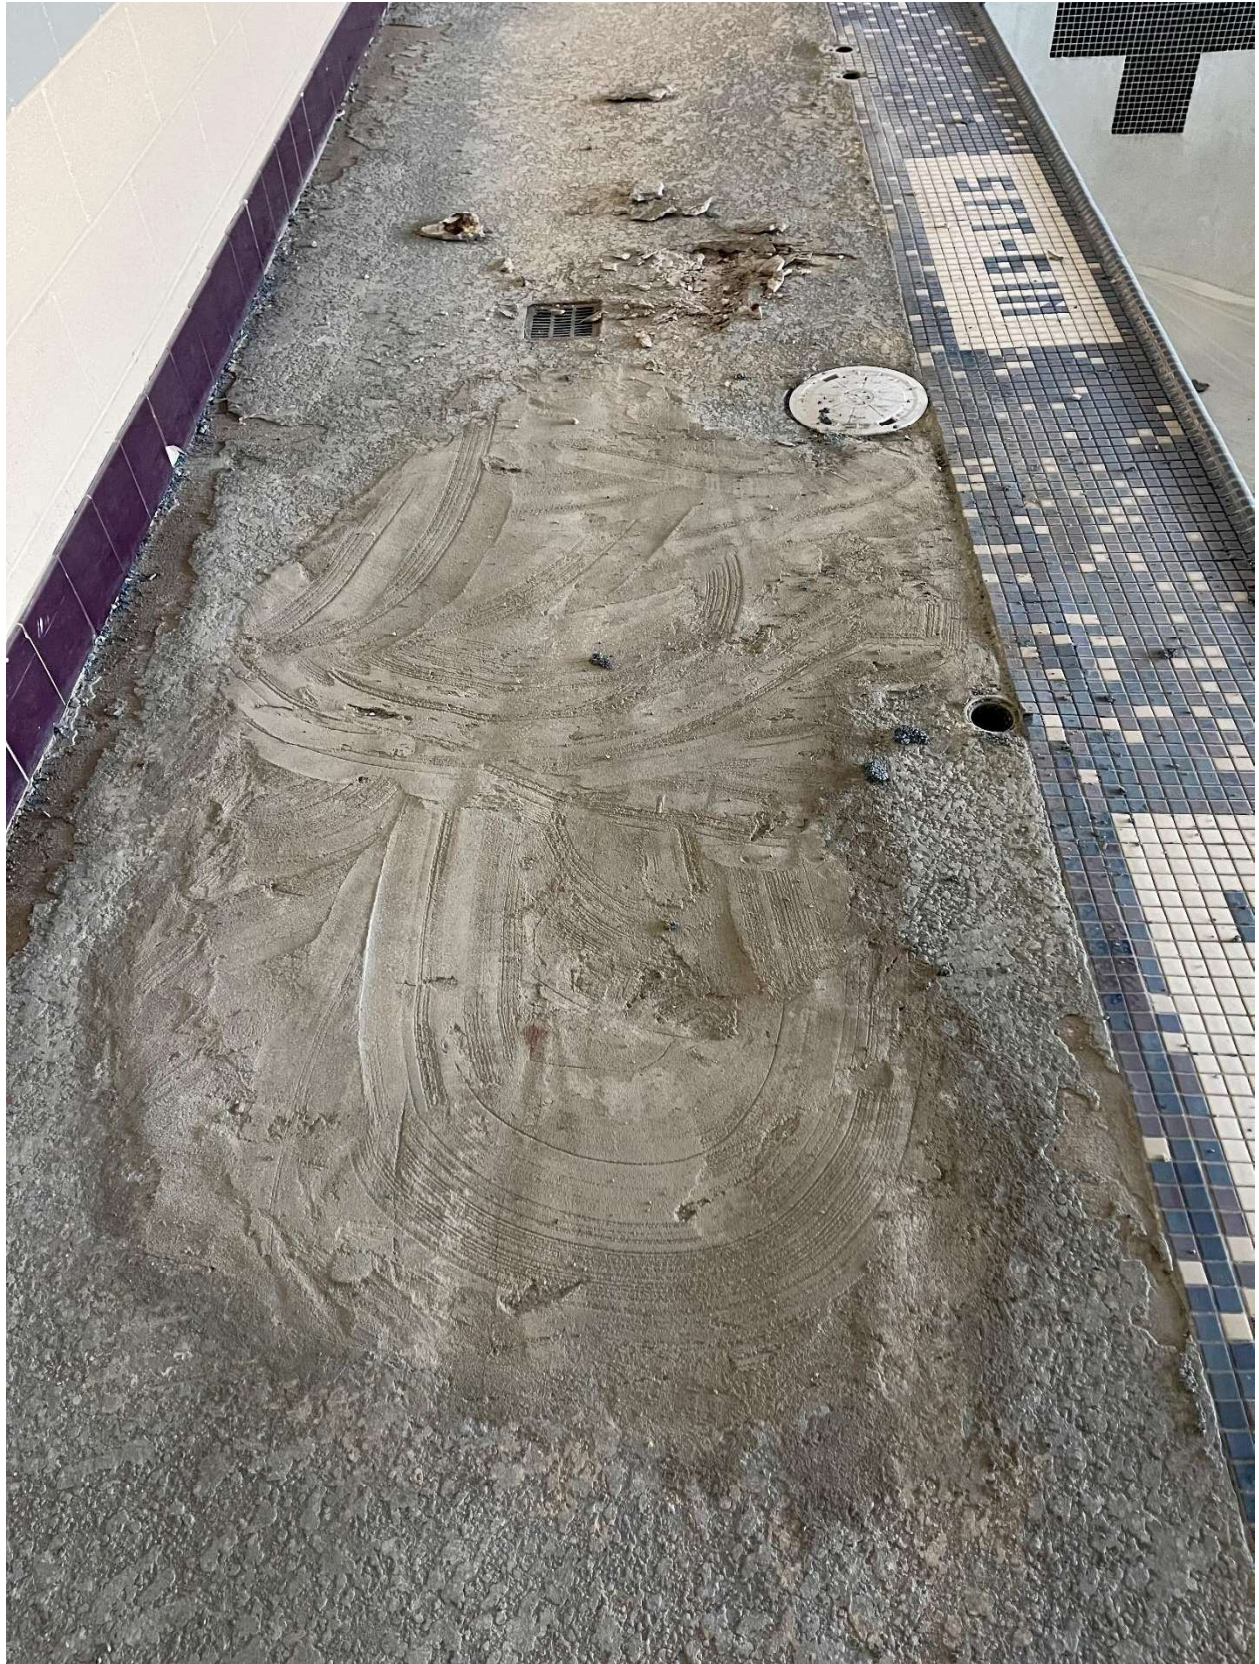
The site appears to be in general conformance to the plans provided to Brannon Corporation. Layout and deck thicknesses appear to comply with S2.1 of the 2003 plan set provided. The existing pool had been drained and the granular rubber finish removed. Most locations still have a concrete coating finish. The existing deck had evidence of past repairs as shown in Figure 13 of the Appendix.
