Water Slide Inspection Report 2019 - 1

Water Slide Inspection Report 2019 - 1 Conducted on 21st May, 2019 By Mike Shaw

City of Keller

Keller Pointe

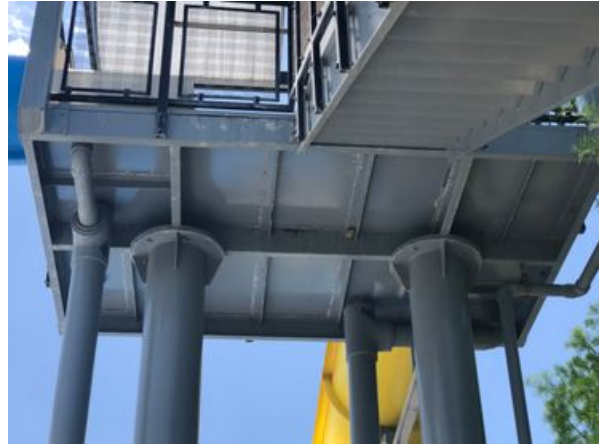
Photo 2

Some rust showing under top platform. This should be monitored and properly treated and maintained to prevent further corrosion and/or deterioration.

Outdoor - monitor and treat rust under upper platform

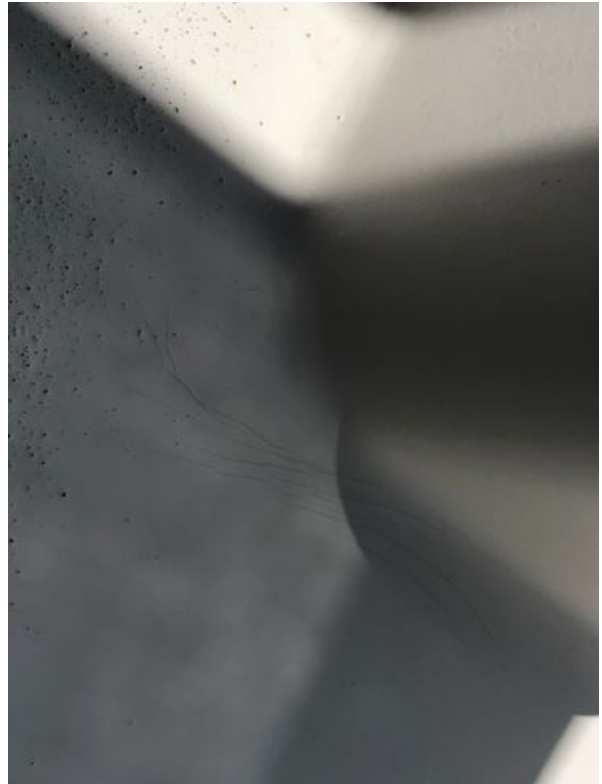
Photo 4

Some surface cracks in gelcoat. Continue to monitor for further cracking or expansion.

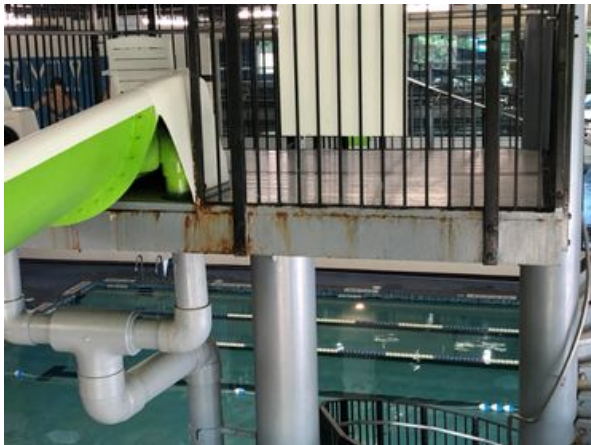
Photo 7

Significant rust and corrosion were again identified on the main stair tower of the structure as well as most of the other support columns, arms, and connective hardware.

Indoor - evaluate rust, corrosion, and deterioration on tower components, fasteners, and other hardware and develop an appropriate response and plan of action to address.

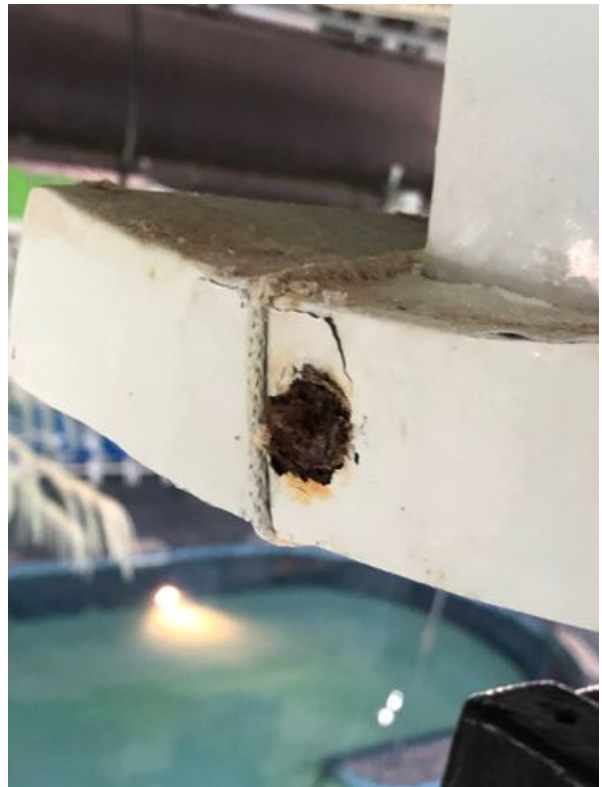
Photo 12

While some hardware appears in good condition, other connectors are showing signs of deterioration from corrosion.

Connectors on the decorative awning at the top of the slide tower has at least one severely deteriorated fastener as well as the support from the ceiling.

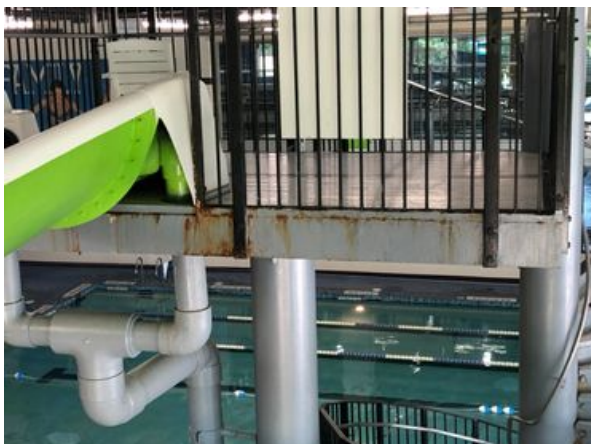
Photo 19

While the newly replaced bolts connecting the stairs to the tower appear to be in good condition, other components of the stairs, including stair risers/treads and handrail materials, do not.

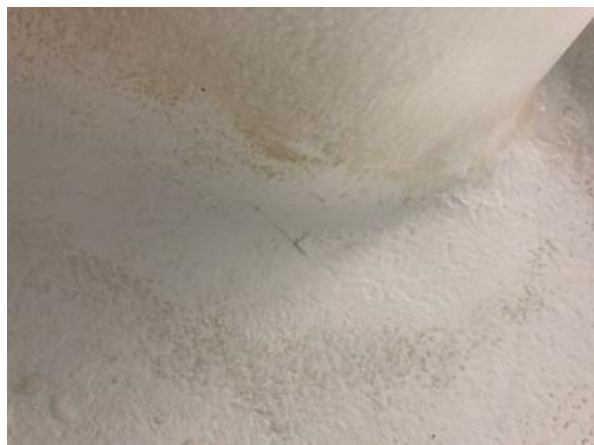
Photo 21

Small cracks notes in start tub gelcoat. Monitor for growth or worsening.
