July 19, 2019

The Keller Pointe
405 Rufe Snow Drive
Keller, TX 76248

Re: The Keller Pointe
Water Slide Tower Structural Inspection

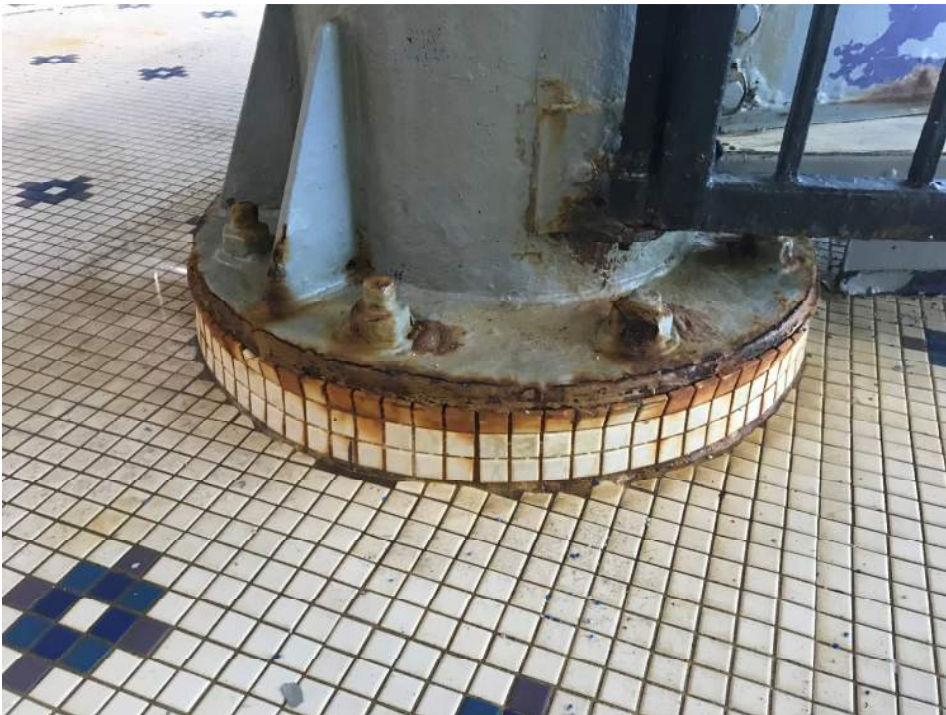
- The spiral stair column does not have double bolts on the anchor bolts to the baseplate. This item was flagged by the state inspector as being unacceptable so this will need to be rectified with chipping down existing concrete to allow access to the anchor bolts. They will then need to be cut and coupled to allow for additional bolt threads to be available to place two nuts on each bolt. The chipped-out area would then have concrete placed again.

Example of Bolt Rust on Spiral Stair Column Anchor Bolts

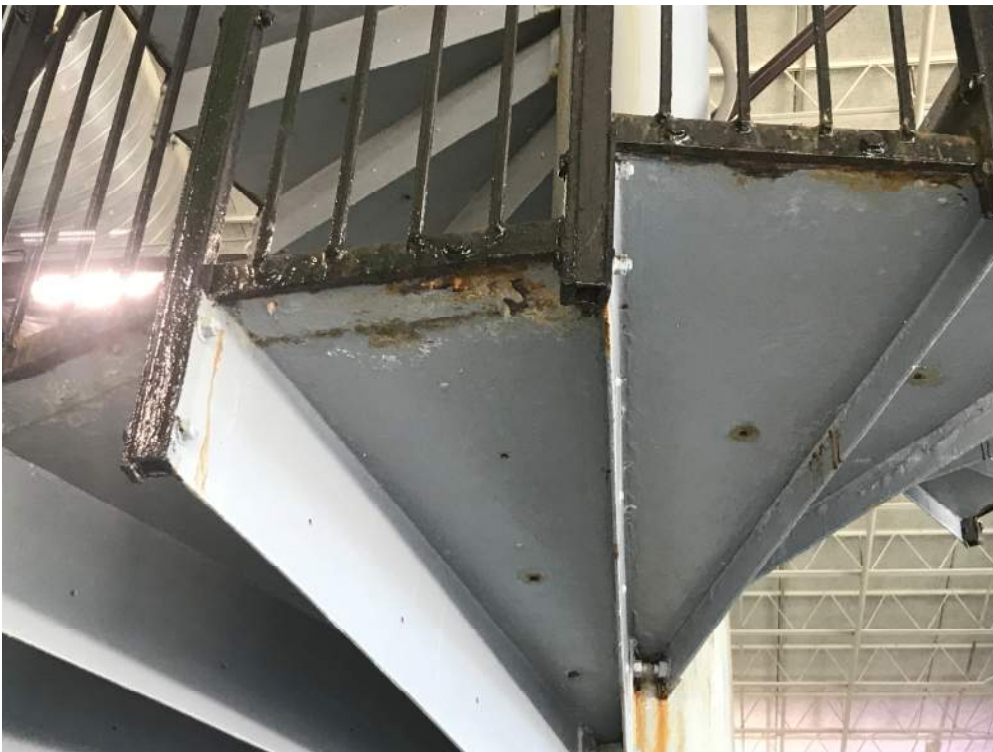
corrosion found, especially near the slide on the start tub platform. The railing on the spiral stairs was painted over several times. It was difficult to determine how badly the steel has corroded. It could be blasted to see how far down it goes, but from a visual and price perspective, it would be recommended to just have it replaced.

Example of Rust on Spiral Stairs and Railing

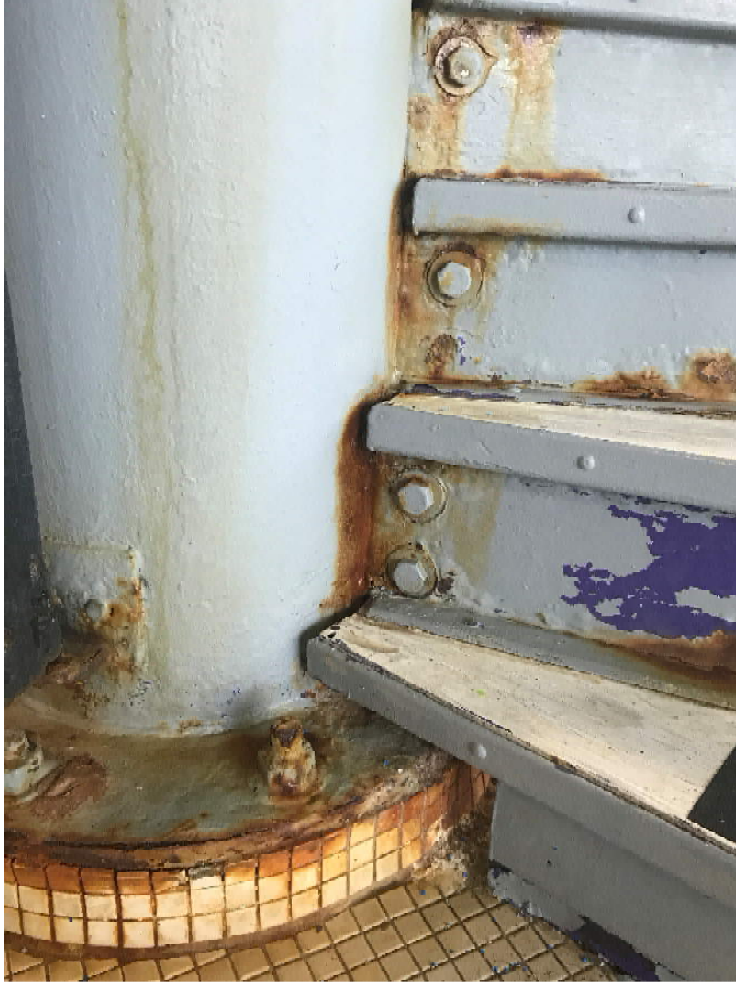
- All columns did not have weep holes. It is recommended that they be drilled to allow for drainage of any fluid buildup inside the column.
- The spiral stair column showed large amounts of rust and chipped paint/powder coat. At time of inspection it was not possible to determine how far the corrosion went into the column. It is recommended that a minimum it be blasted, inspected after, and then powder coated again. The best recommendation would be to have it, the stairs, and associated steel/connections on the spiral be replaced.

Example of Spiral Stair Connection Rust

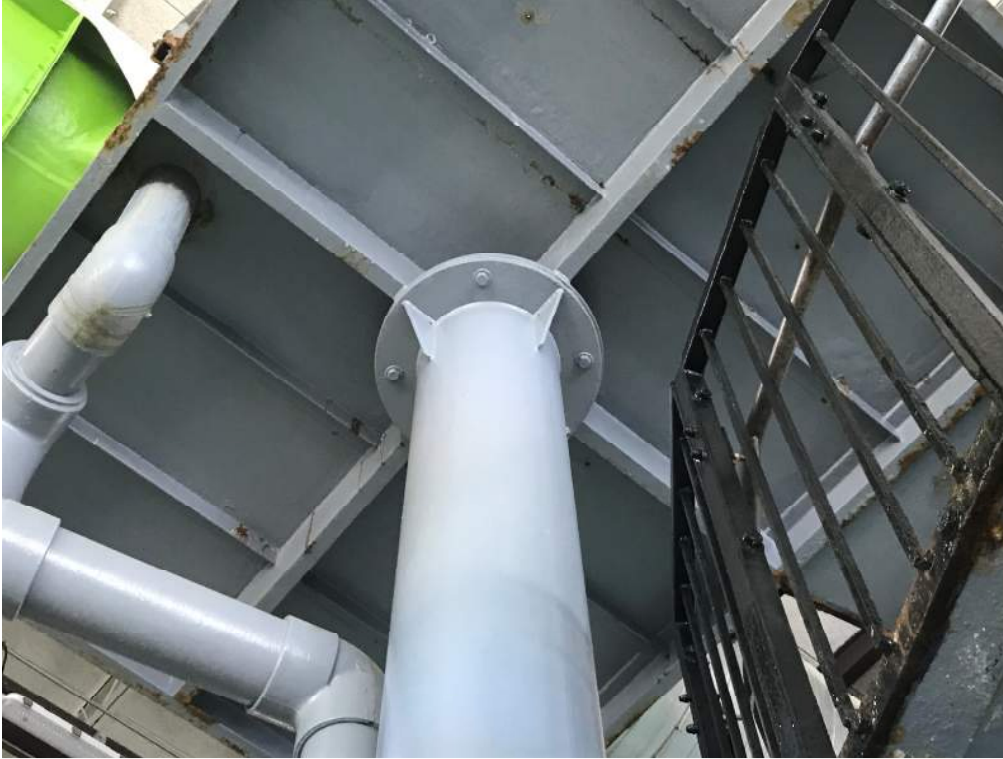
Example of Tower Rust and Chipped Paint

- Surface rust and chipped powder coat/paint were noticed on the tower platform and arms supporting the slide. These rusting surfaces shall be prepared per the manufacturer's recommendation, then coated with POR15 followed by Sherwin Williams Acrolon 218.

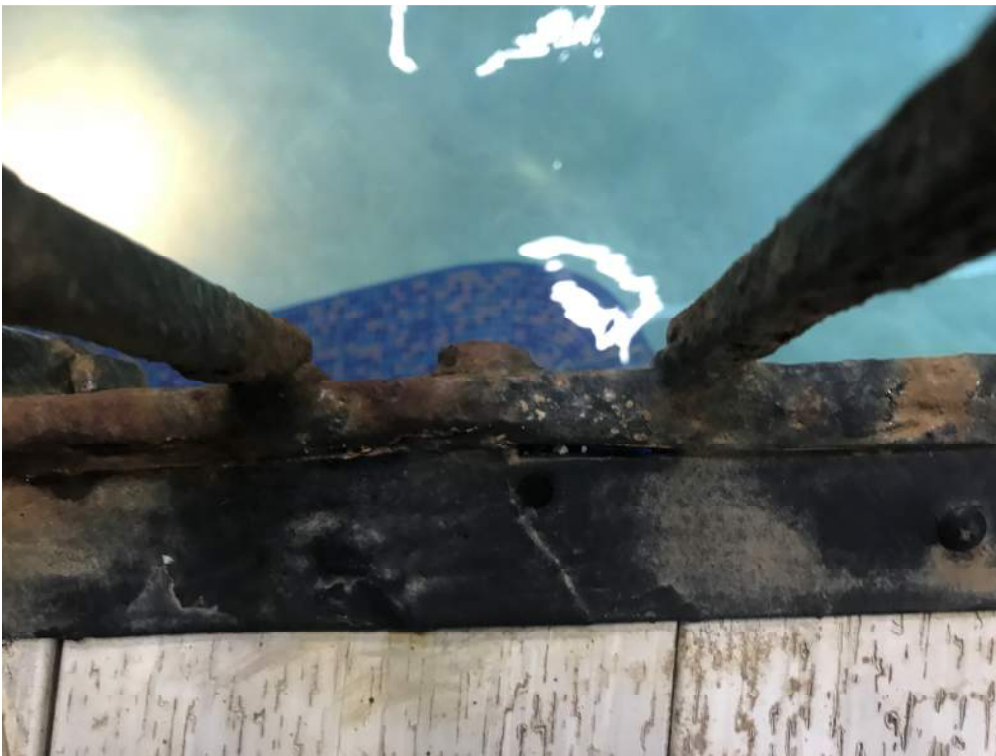
- During the inspection, rust and chips was viewed in a several locations on the railing steel. It is recommended that several sections of the railing be replaced due to the high amounts of

Example of High Corrosion on Railing at Slide Platform

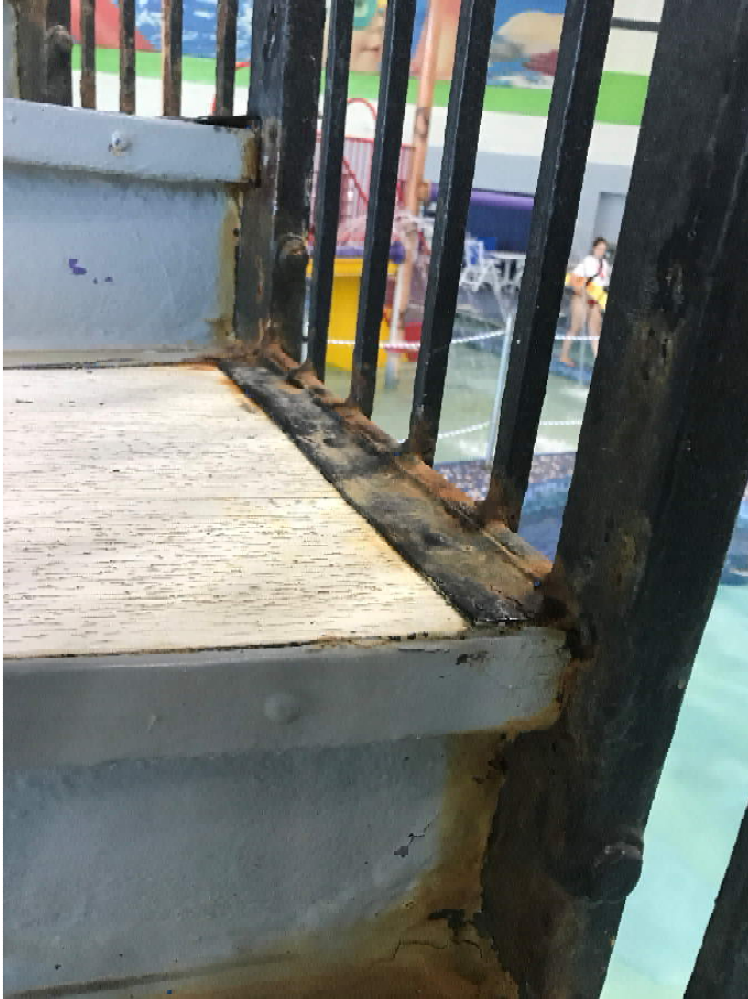
Example of Rust on Stairs and Railing

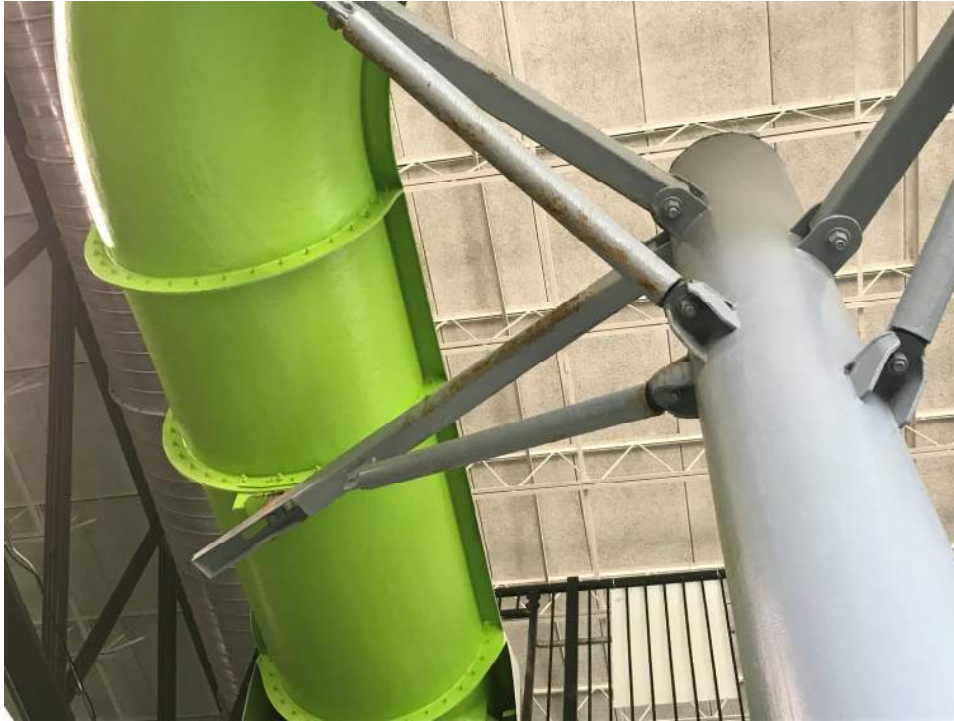
Example of Rust on Slide Support Arms

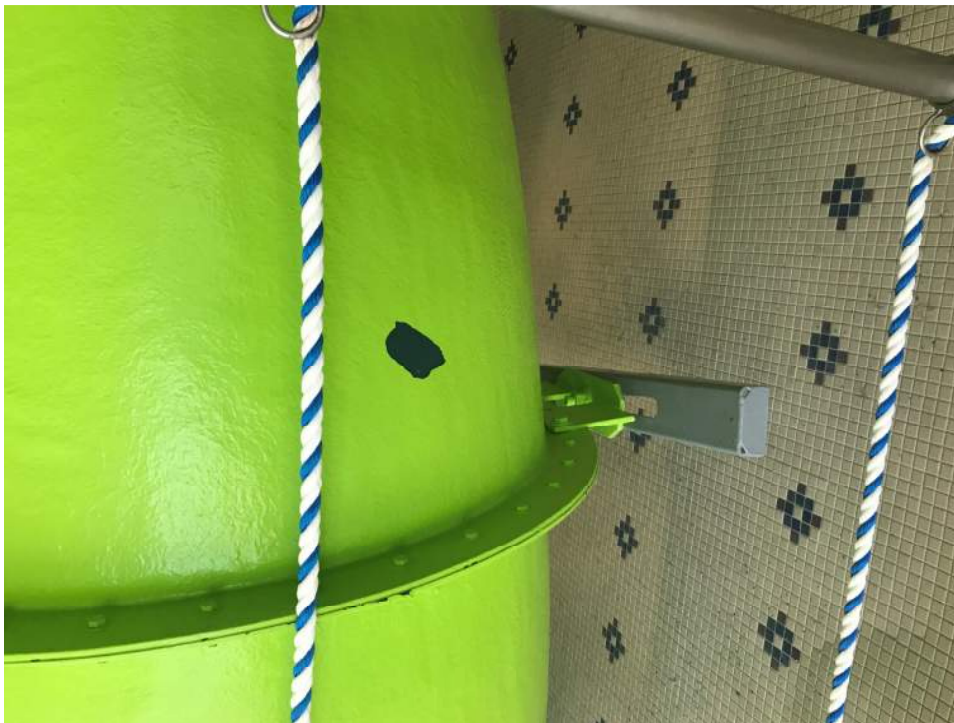
- The fiberglass inspection found the ride surface or gel coat has some general wear and tear but is in good condition overall. In a few locations, chips and scratches were found. It was mentioned that another contractor would be coming back to gel coat it again but if at any time Splashtacular can be of assistance or perform the replacement gel coat please do not hesitate to contact us. It is recommended that after repair, the ride surface be cleaned buffed and waxed. The slide can be waxed using Turtle Wax Ice.

Example of Chipped Gel Coat on Slide
