# Bear Creek Parkway & Keller Smithfield Traffic Signal Warrant Study Update

Alonzo Liñán  
Director of Public Works  
February 5, 2019

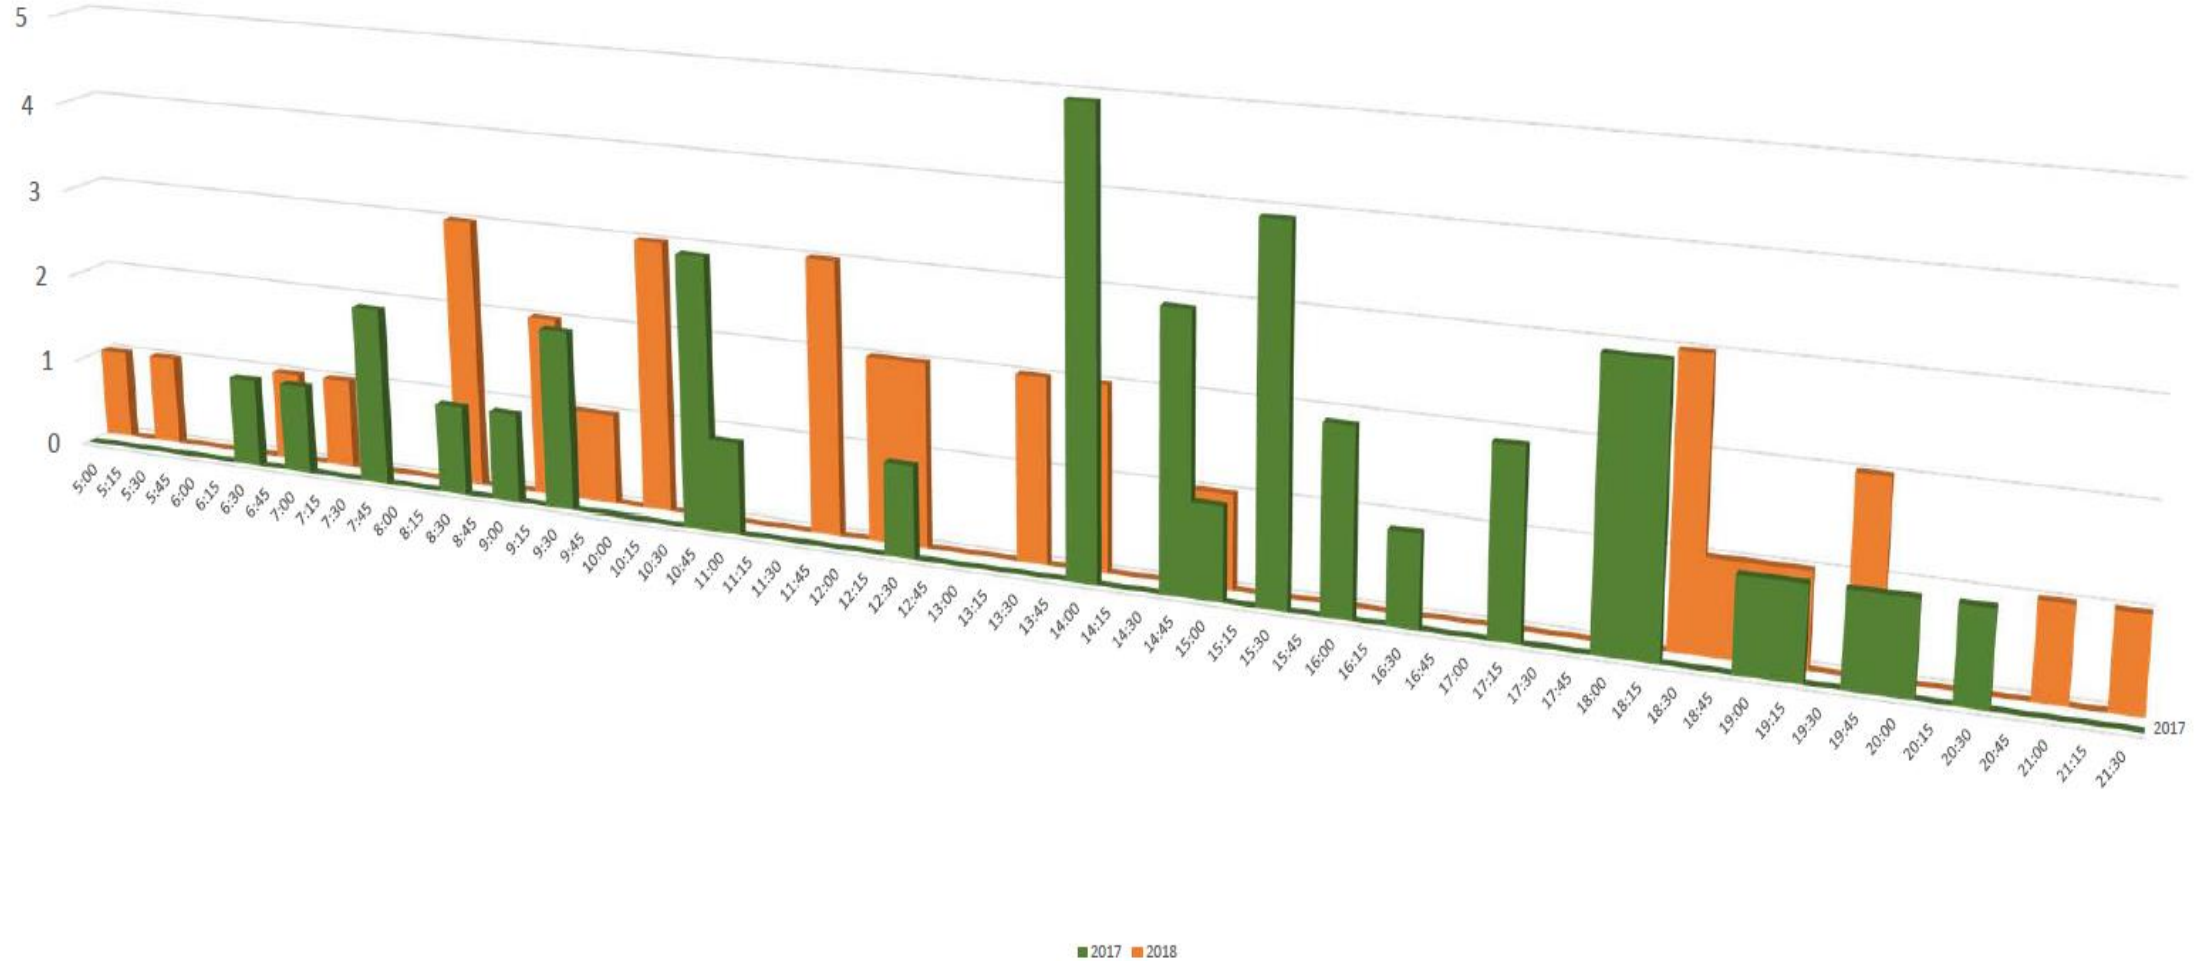
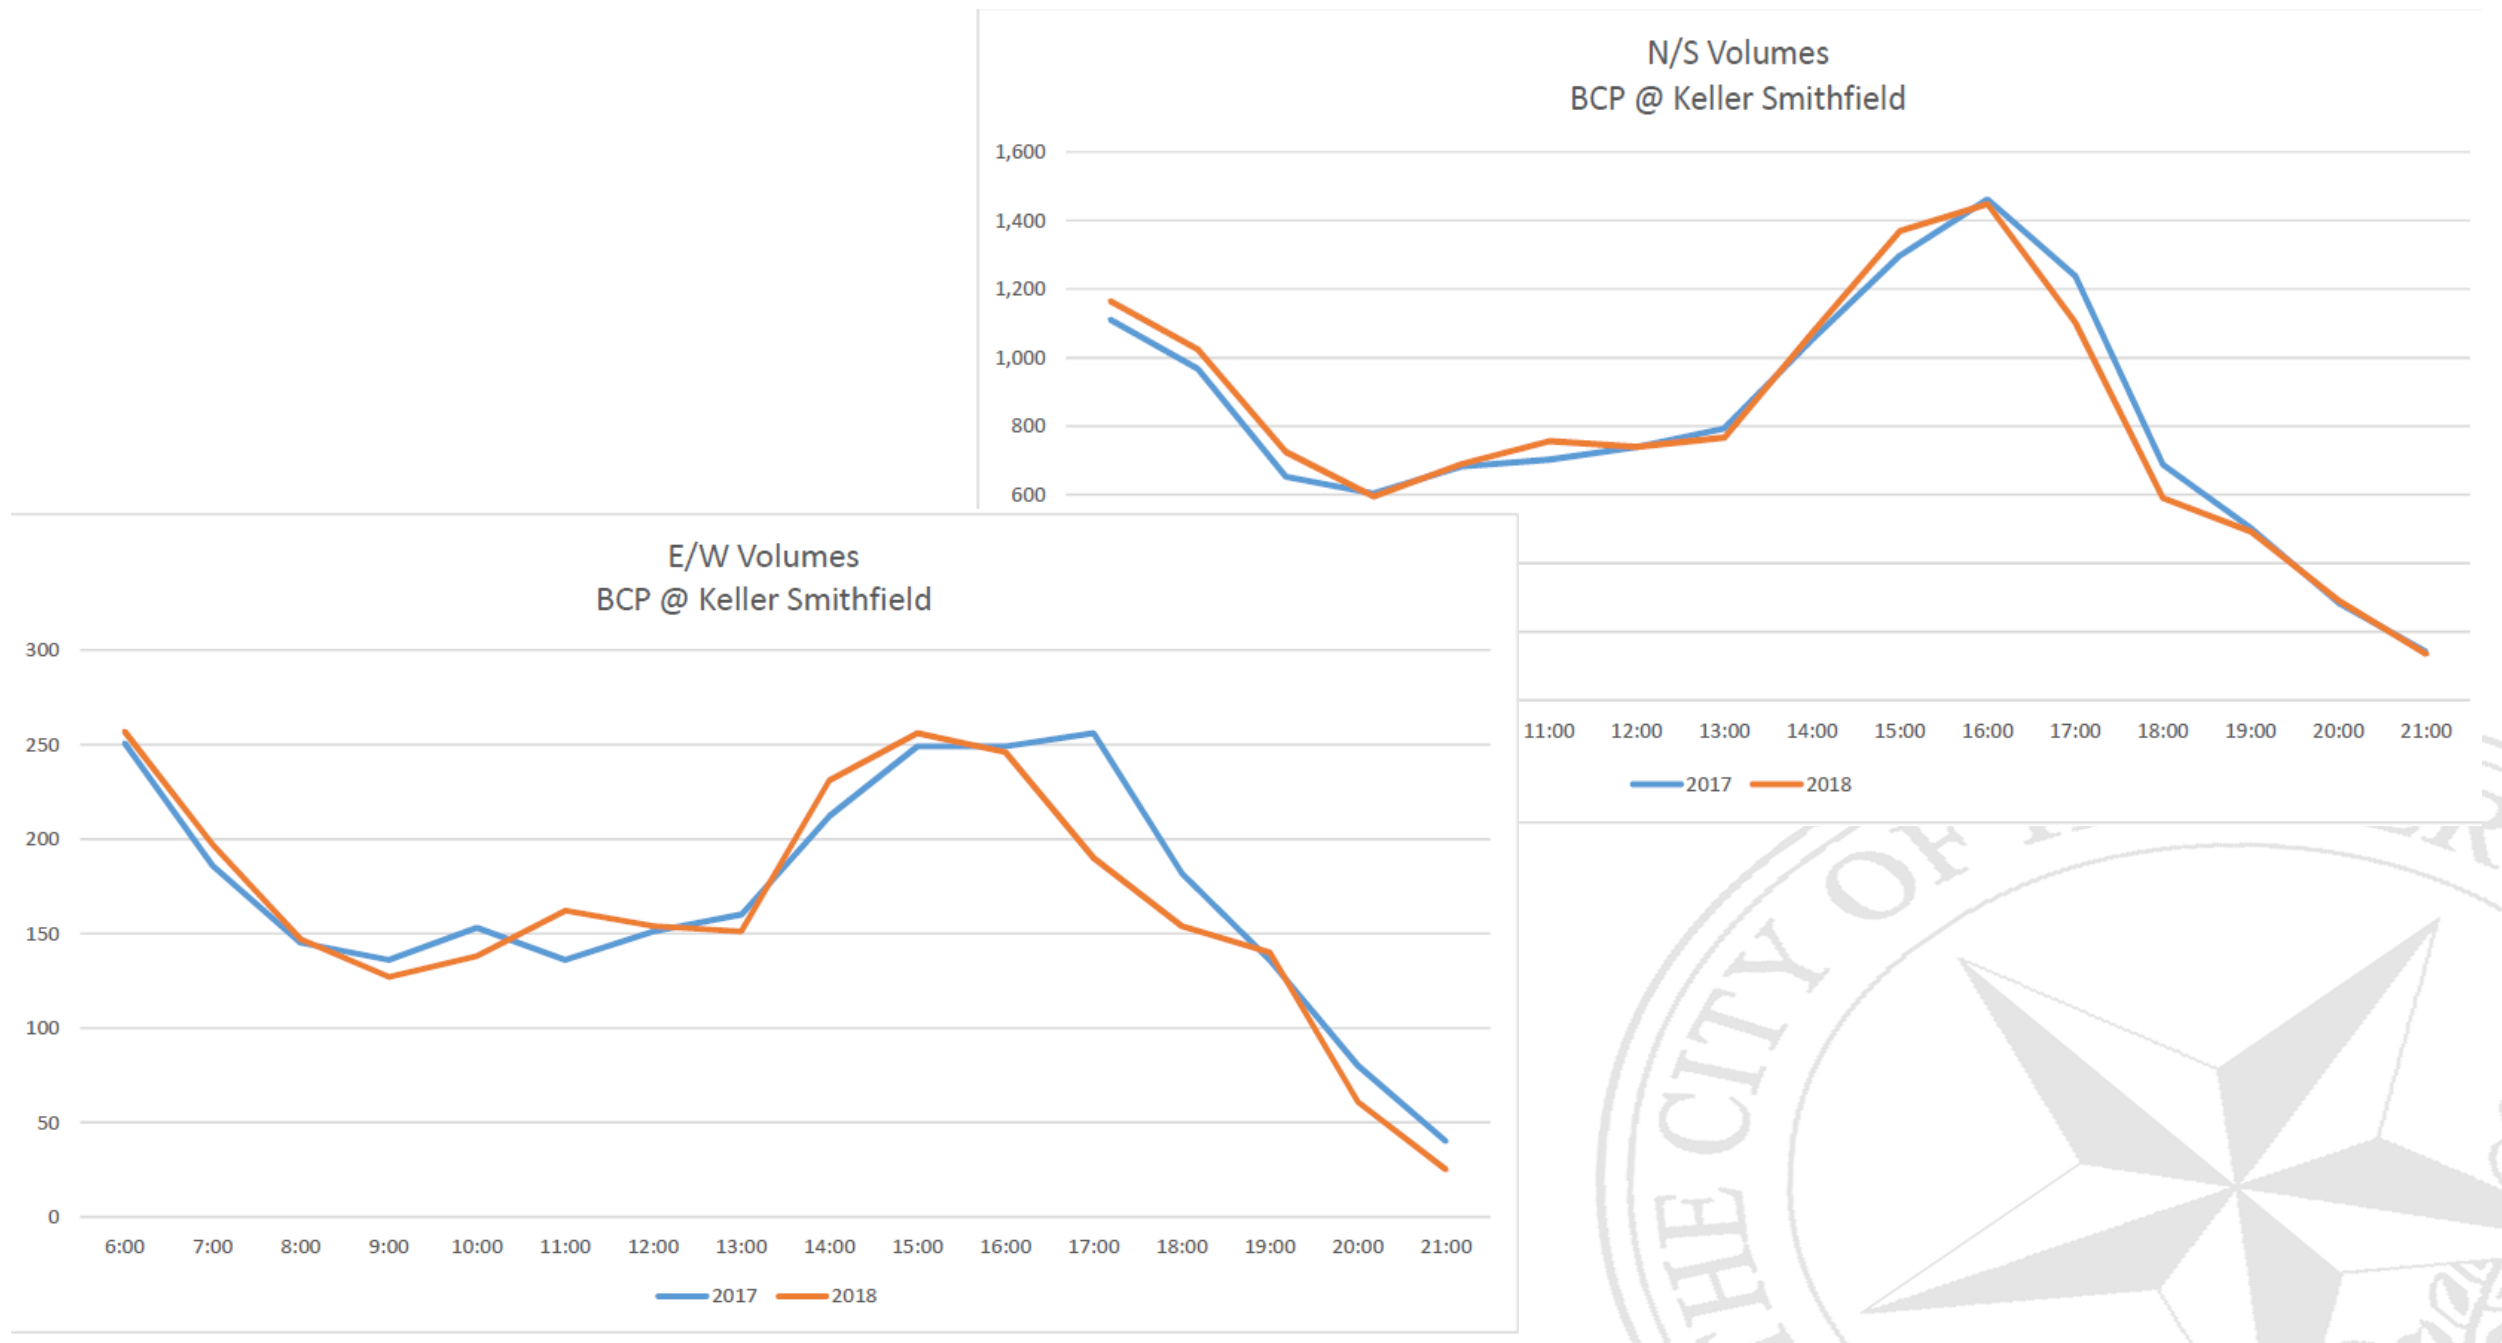
## Pedestrian Counts by Year

at Keller Smithfield & Bear Creek Parkway (North)
