# Citywide Street Condition Inventory Results and 5 Yr. Road Maintenance Priorities

**Alonzo Liñán, PE, PTOE**  
**Director of Public Works**  
**April 6, 2021**

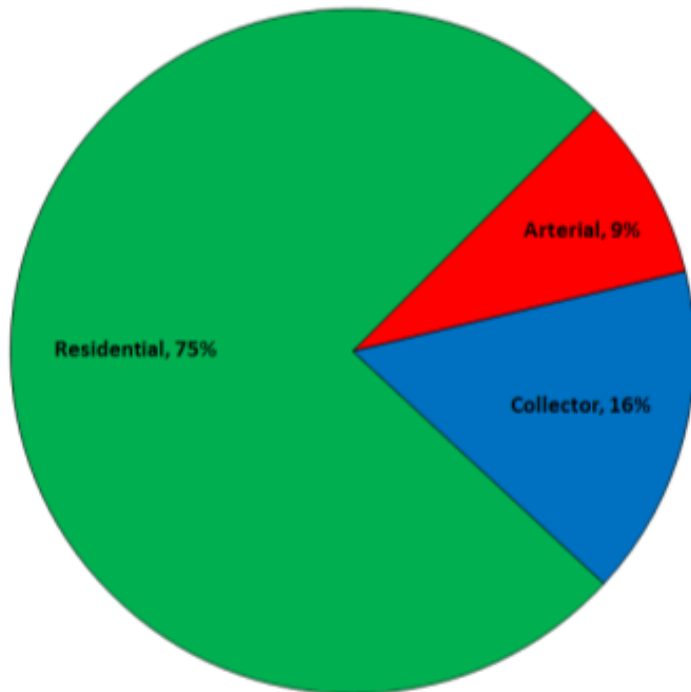
% of Network	2015	2020
Arterial	4%	4%
Collector	17%	16%
Residential	79%	80%
	100%	100%

Lane Miles	2015	2020
Arterial	8.5	8.6
Collector	32.7	32.9
Residential	155.6	160.0
	196.7	201.5

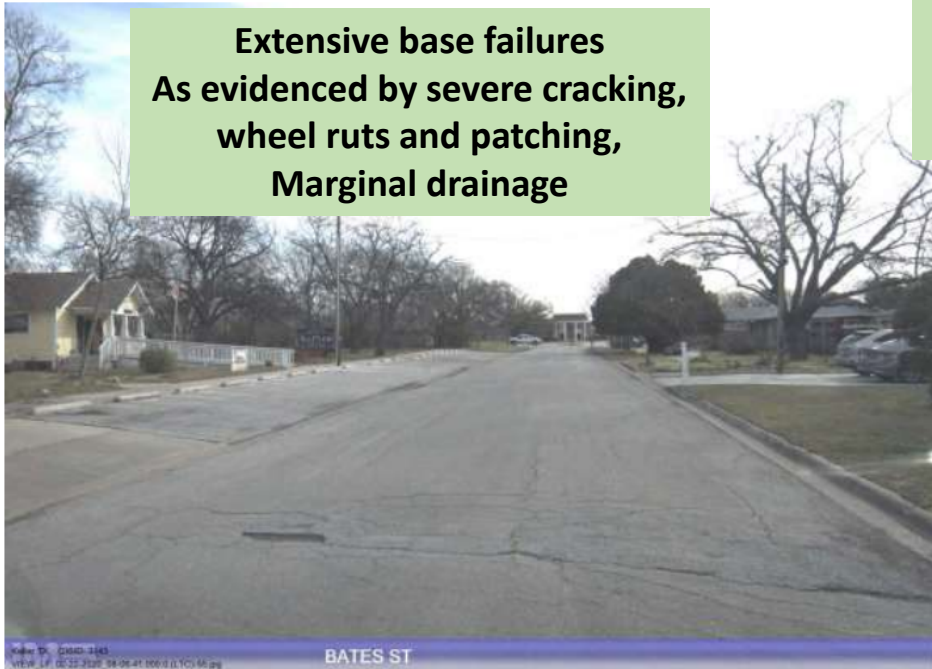
Bates Street

Very Poor (PCI = 0 to 35) – Complete Reconstruction

**Extensive base failures**  
As evidenced by severe cracking,  
wheel ruts and patching,  
Marginal drainage

**Past the point of an overlay,**  
Delay in reconstruction will not  
increase costs, Work driven by  
complaints & safety or other

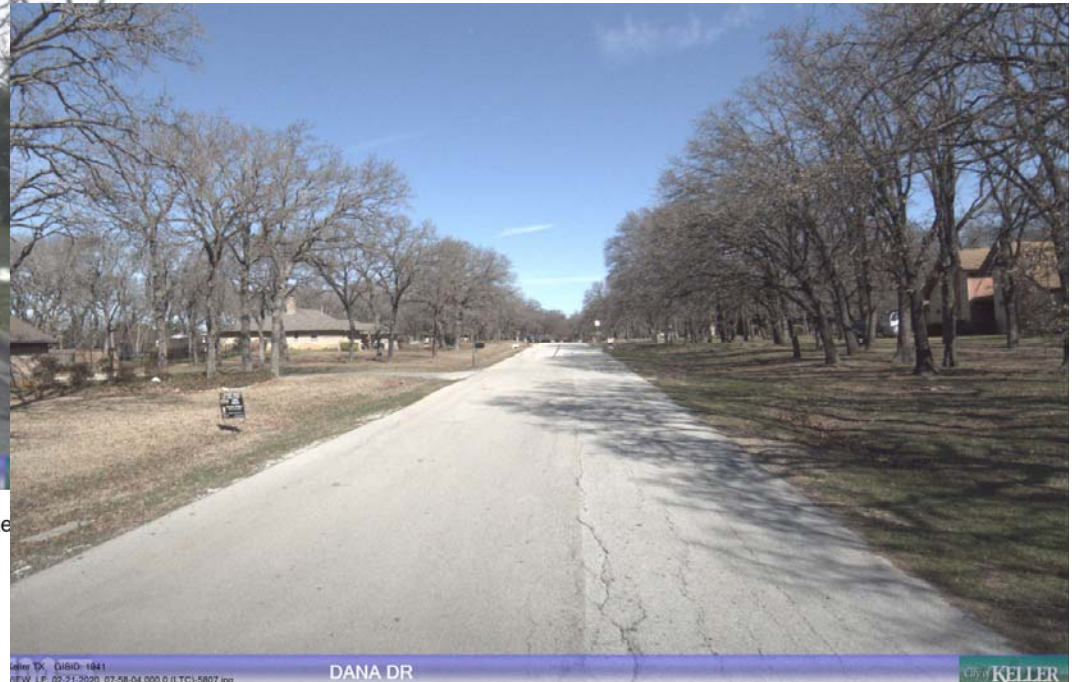
3143, PCI = 33) – Rate

**Localized base failures**  
Rutting at intersections  
Extensive cracking  
Extensive patching

**Thick overlay or mill and OL,**  
Extensive joint, panel  
replacement, and grinding on  
PCC roads

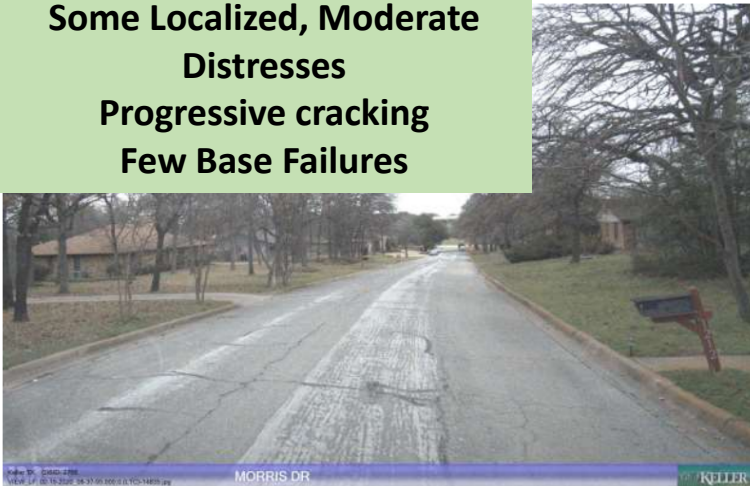
Marginal (PCI = 45 to 55) – Progressively Thicker Overlays

**Some Localized, Moderate Distresses**  
**Progressive cracking**  
**Few Base Failures**

**Thin to Moderate Overlays**  
**Joint Rehab and Panel Replacement for PCC**

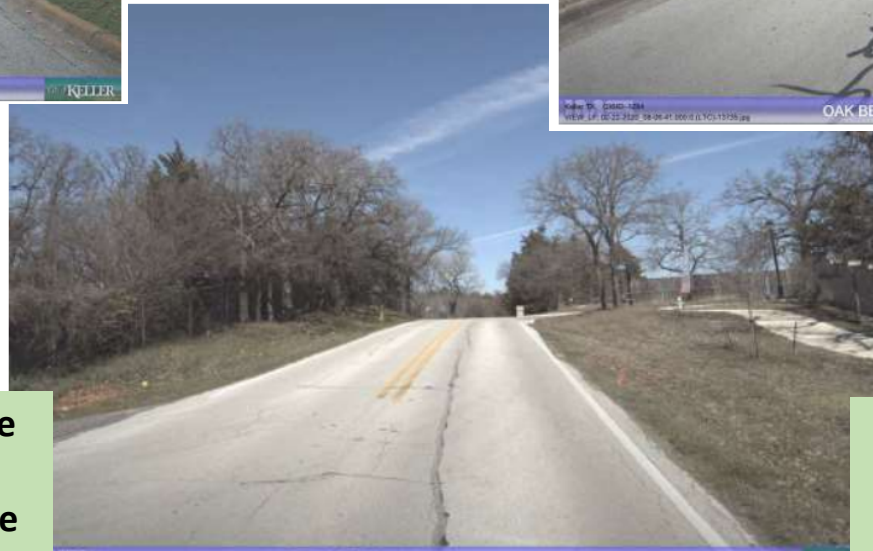
Good (PCI = 65 to 75) – Surface Treat.

**Close to New Condition**  
**Small Visual Distresses**  
**Smooth Ride, Strong Base**

**Crack Seal and Heavy Surface Candidate**  
**Occasional Dig Out & Replace**

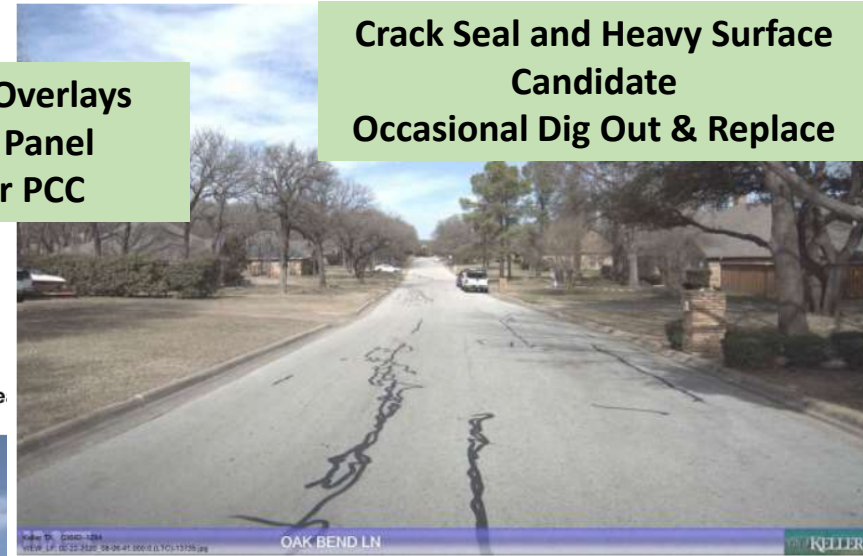
Fair (PCI = 55 to 65) – Thin to Moderate Overlays

**Few Localized, Moderate Distresses**  
**Non-Load Related**

**Crack Seal and Heavy Surface Treatment Candidate**  
**Occasional Dig Out & Replace**

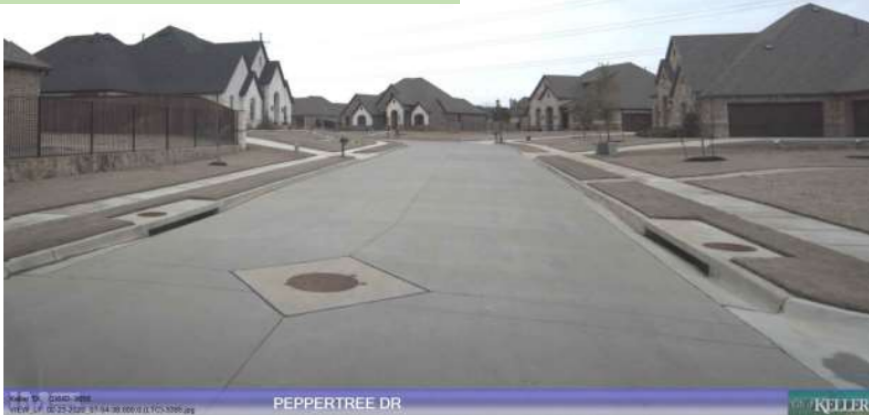
Very Good (PCI = 75 to 85) – Surface Treatments and Localized Rehabilitation

**Close to New Condition**  
**Minor Cracking & Distresses**  
**Smooth Ride, Strong Base**

**Good Candidate for Preventative**  
**Maintenance and Light-Weight**  
**Surface Treatments**

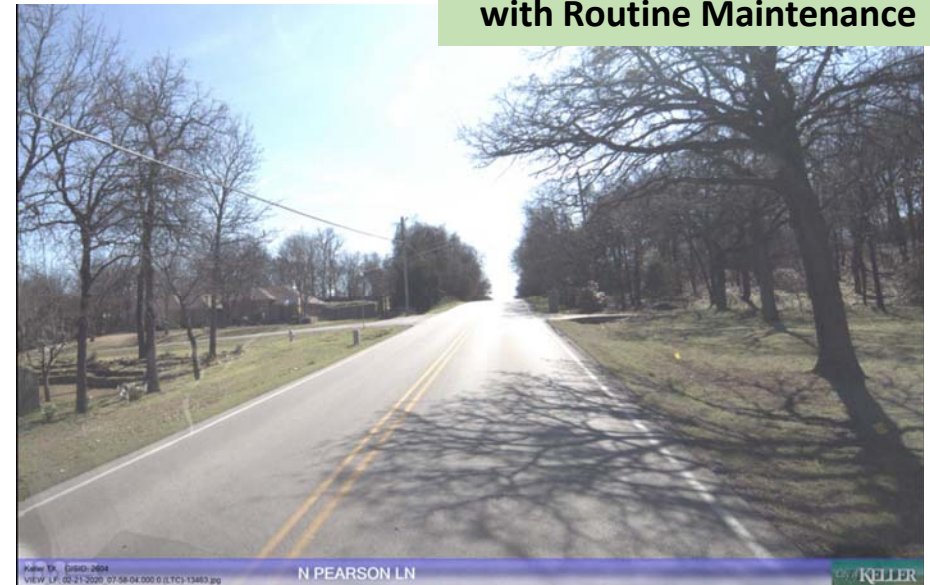
**Like-New Condition**  
**Very Few Minor Distresses**  
**Smooth Ride, Good Drainage**

**Should Provide 5-10 years**  
**Prior to First Rehabilitation**  
**with Routine Maintenance**
