Water Slide Inspection Report 2019 - 1

Water Slide Inspection Report 2019 - 1 Conducted on 21st May, 2019 By Mike Shaw

City of Keller

Keller Pointe

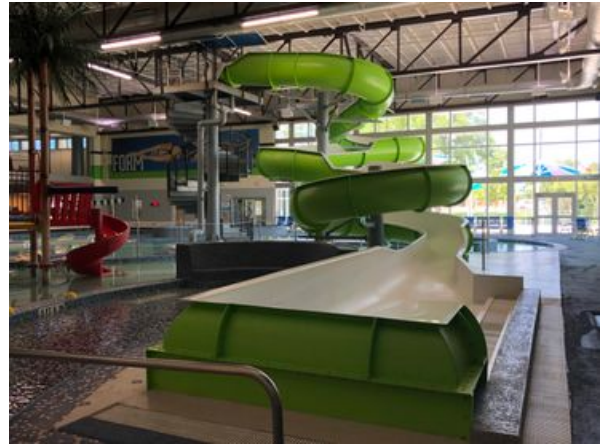
Photo 6

Significant rust and corrosion were again identified on the main stair tower of the structure as well as most of the other support columns, arms, and connective hardware.
